## Omega 23221 (Taiwan) Air Motor Hook-Up

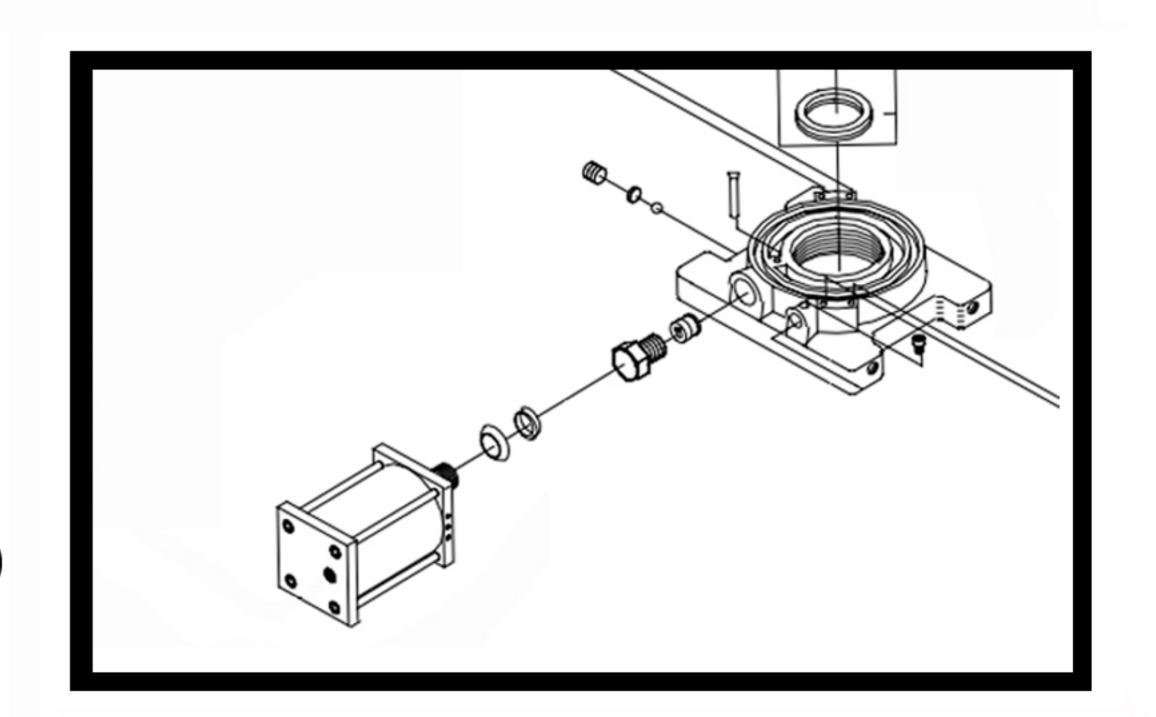
## 2321 Taiwan (Old Version) Uses Repair Kit A07-3-9903-105

- Air Motor Connects Directly to the Base.
- For Jacks Made in Taiwan with a Serial Number Starting with 0202 (Feb 2002) and Earlier.

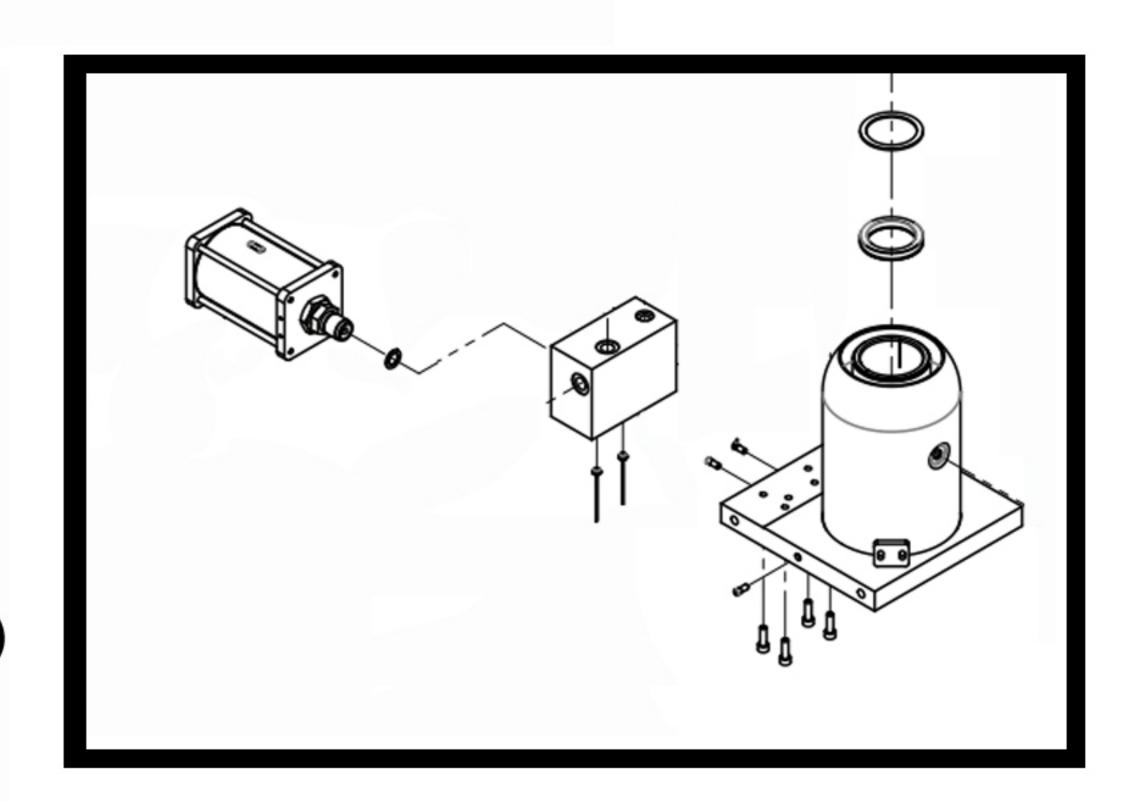
## 2321 Taiwan Uses Repair Kit A0901S-077

- Air Motor Connects to the Base via the Valve Block.
- For Jacks Made in Taiwan with a Serial Number Starting with 0203 (Mar 2002) and Later.
