ADVISORY

February 20, 2013

YA786 2-ton Aluminum Service Jack

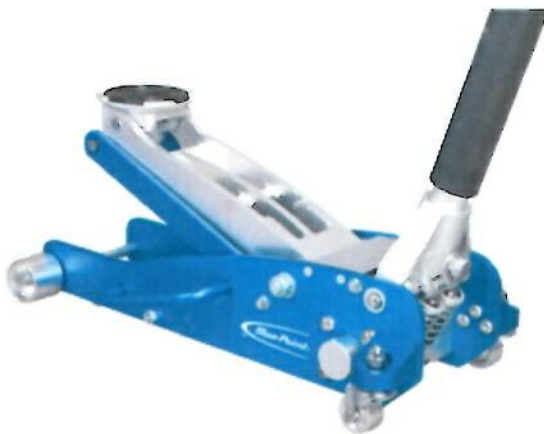
Figure 1. “YA786 2-Ton Aluminum Floor Jack”

1. Do not continue to pump the YA786 (or any Floor Jack) against a “dead-head” when full height is reached.
2. Do not alter the pressure release setting.
3. If a vehicle is stuck in the lifted position:
 - Position support stands under the vehicle.
 - Use another Floor Jack to lift the vehicle off the YA786 Jack.
 - Remove the YA786 Jack and support stands and carefully lower the vehicle.
4. If you experience this problem or have concerns in this regard, return your YA786 to a Snap-on Franchisee for full credit.
