223 170 AIR/HYD PUMP  
BEER KIT# 2781 561

**SERVICE ADJUSTMENT PROCEDURE—223170 AIR HYDRAULIC PUMP**

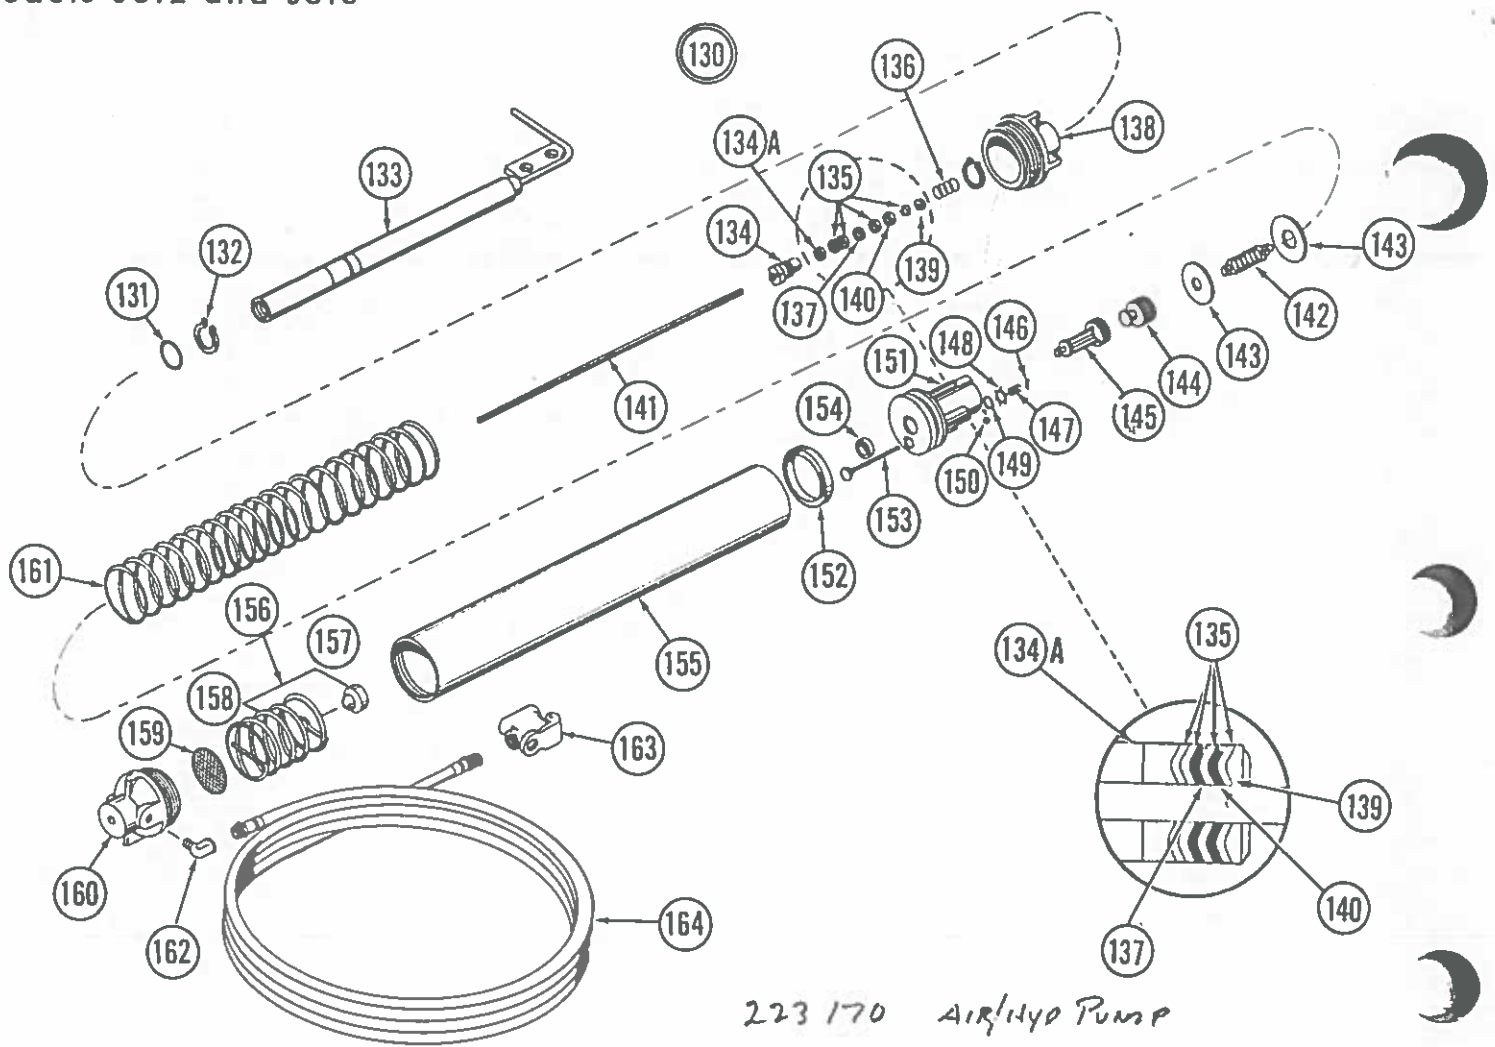
Code No.	Description	No. Req.	J612 Part No.	J613 Part No.
130	Air Hydraulic Pump Assembly	1	223170	223170
131	"O" Ring - Pump Assembly	1	219861	219861
132	Retaining Ring - Pump Assembly	2	221820	221820
133	Pump Cyl. & Ext. Tube Assembly	1	223198	223198
134	Gland Nut	1	223177	223177
134-A	Adaptor	1	223195	223195
135	"V" Packing - Pump Rod Gland	4	223171	223171
136	Pump Cyl. Spring	1	223174	223174
137	Teflon Packing	1	223681	223681
138	End Block	1	223193	223193
139	Adaptor	1	223196	223196
140	"V" Packing - Rubber	1	225071	225071
141	Pump Rod	1	223186	223186
142	Trip Spring	1	225384	225384
143	Trip Washer	2	223203	223203
144	Plug	1	223183	223183
145	Pump Piston Assem.	1	223678	223678
146	Hair Pin Cotter	1	223185	223185

Code No.	Description	No. Req.	J612 Part No.	J613 Part No.
147	Spring	1	223184	223184
148	Retaining Ring	1	223268	223268
149	"O" Ring	1	222288	222288
150	Lead Ball	1	220834	220834
151	Piston Assembly	1	223181	223181
151	Piston (Only)	1	224387	224387
152	"U" Cup	1	223182	223182
153	Valve Plunger Assembly	1	223187	223187
154	"U" Cup	1	221013	221013
155	Air Cylinder	1	223176	223176
156	Spring & Rubber Cushion Assem.	1	223194	223194
157	Rubber Cushion	1	225371	225371
158	Spring	1	223175	223175
159	Screen	1	223680	223680
160	Air Cyl. Cap	1	223192	223192
161	Return Spring	1	223173	223173
162	Elbow - Air Hose	1	222202	222202
163	Air Valve	1	223180	223180
164	Air Hose Assem.	1	224021	224021

- I. If Air-Hydraulic Jack will not lift but sounds normal:
  - A. It is probably air bound. To correct, tip jack on its left side (as viewed from handle end) and cycle the air pump slowly.

- B. The Hydramatic valve might be stuck open. To check, open release, pull bellcrank up to full height by hand, close the release valve while at full height and let go of the bellcrank. If it returns to low position, the trouble is in the hydraulic unit. If it holds position, lower the jack and try to make a lift with the air pump. If successful, the trouble was in the Hydramatic and raising the bellcrank by hand corrected it.

- II. If Air-Hydraulic Jack will not lift and does not sound normal, look for the following:
  - A. If the air pump is cycling unusually fast:
    1. The jack may be air bound.

2. The suction ball in the hydraulic unit may not be seating.
  - B. If the air pump is not cycling at all, but air can be heard rushing out the exhaust port, the air pump should be removed and checked for the following:

1. Rubber bumper on cushion spring may have been dislodged from the spring.
    2. The valve plunger assembly 223187 may be stuck open.
    3. The two weep holes in the pump retainer plug 223183 may be plugged with dirt.

4. The return spring 223173 may be broken.
  - C. If the air pump is not cycling at all and no air is coming out of the exhaust, check for the following:

1. The pump rod 223186 may be frozen in its packing gland.
    2. The Valve Plunger Assembly 223187 is not opening. Look for a bent Trip Washer or a bent or rusted Valve Plunger which has seized in the piston.

- III. If the jack will raise a load but much more slowly than normal, the trouble is almost certainly related to the air pump. Look for the following:

- A. If the pump cycles very slowly:
    1. There may be a restriction in the air line between the air valve and the air pump.
    2. One of the weep holes in the 223183 Pump Retainer Plug may be plugged.

- B. If the pump cycles very rapidly:
    1. There may be an air leak at the threads of the Pump Retainer Plug (223183), allowing the 223678 Piston (plastic) to reseat prematurely. This results in a short stroke and a rapid cycle. Correct by recoating the threads with LOCTITE-HV (1-10).

2. The 220834 Ball Plug may have become dislodged. This part is used to block access drill hole.
    3. The "V" Packings that seal against the Pump Rod may be worn out.

4. The 225384 Trip Spring may be deformed or broken.
